Weekly Construction Report

Hatchery Creek Design/Build Project

Time Period:	September 21-26, 2015	Project No:	1305
Rain Days/Weather Conditions:	No rain this week.		
Personnel on-site:	<i>EcoGro/Ridgewater:</i> Tom Cutter, Eric Dawalt, Larry Mounce, Brad Redmon, Chad Relinski, Randall "Mokie" Starns, Randall Starns, Jr., Sherri Arthur Trucking-John Arthur.		
Equipment on-site:	Komatsu PC 360 excavator w/ hyd. thumb, Komatsu PC 160 w/ hyd. thumb, Komatsu PC 210 excavator, Komatsu PC 240 excavator, Terex TA27 articulated off-road dump truck, & Bobcat T300 skid steer (mobilized Wednesday).		
Material deliveries to project site:	<ul style="list-style-type: none"> 4 rolls of 700 g/SY woven coconut coir erosion control blanket (ECB) and wooden stake. 		
Work performed the past week:	<ul style="list-style-type: none"> Site #3/Step Pool Reach ~Sta. 154+000 to 160+50: <ul style="list-style-type: none"> Finish graded topsoil on slopes and installed wood as organic carbon soil amendment. Built floodplain berm at head of step pools on Right Descending Bank (RDB). Site #2/ ~Sta. 141+00 to 147+00: <ul style="list-style-type: none"> Finished adding spawning gravel to all riffles. Constructed ri

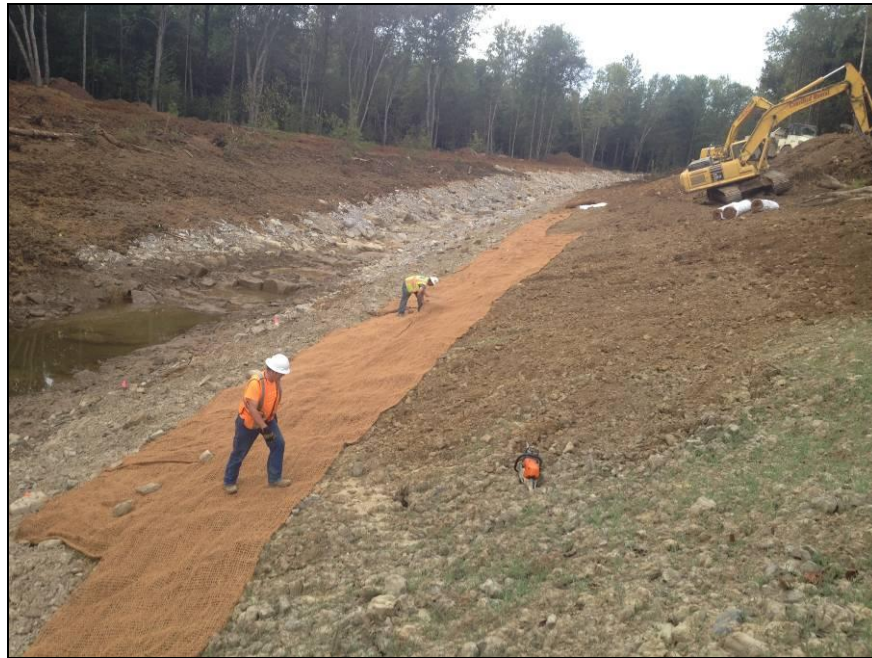
Site #3: Installing erosion control blanket (ECB) on slopes above step pool rock channel. (Picture taken at Cumberland River bank looking upstream).

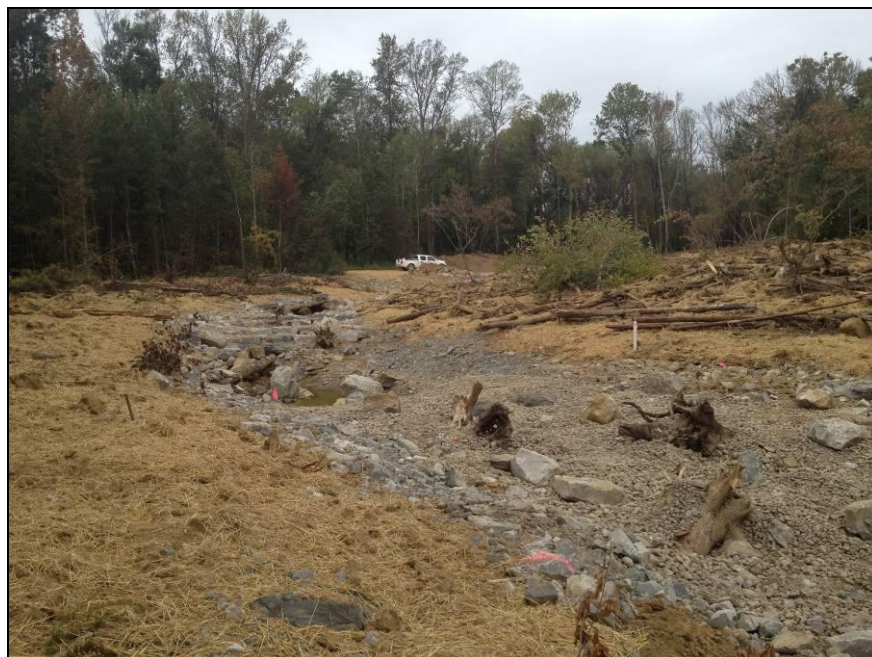
Site #2: Completed channel with seed and straw installed and wood added on top as organic carbon soil amendment. (Picture taken looking upstream from ~ Sta. 147+00).

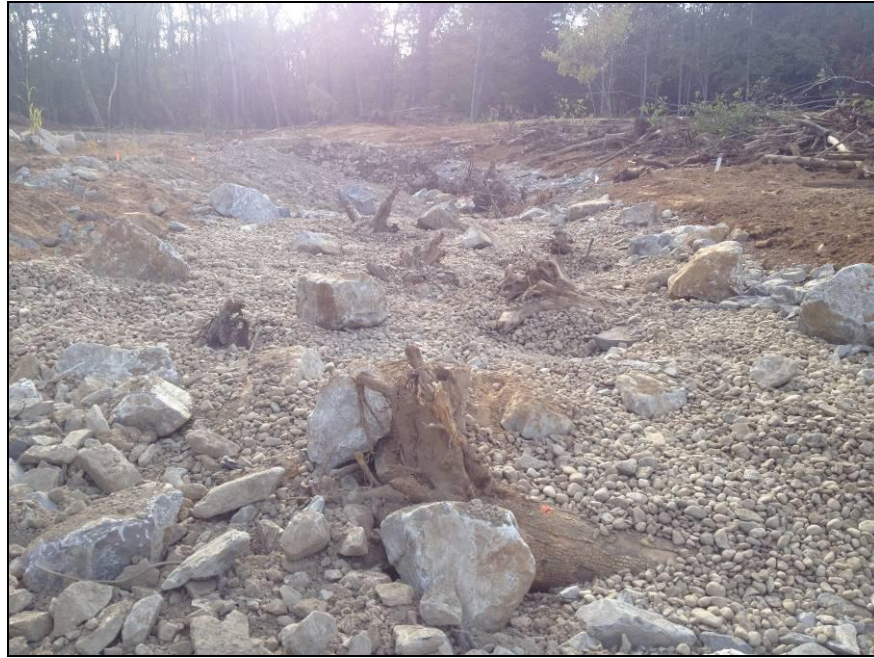
Site #2: Constructed riffle with boulders, rootwads, and spawning gravel throughout. (Picture taken at ~Sta. 144+80 looking upstream).

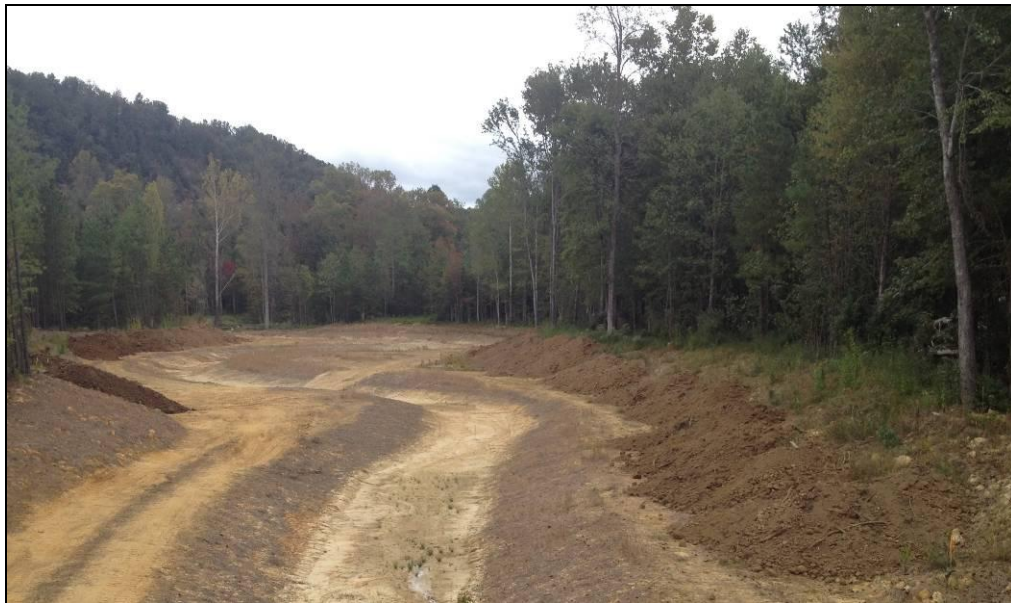
Site #1: ~1400 CY of topsoil was stockpiled on the slopes to cover the poor soil. (Picture taken from Campground Road at ~Sta. 118+00 looking downstream).

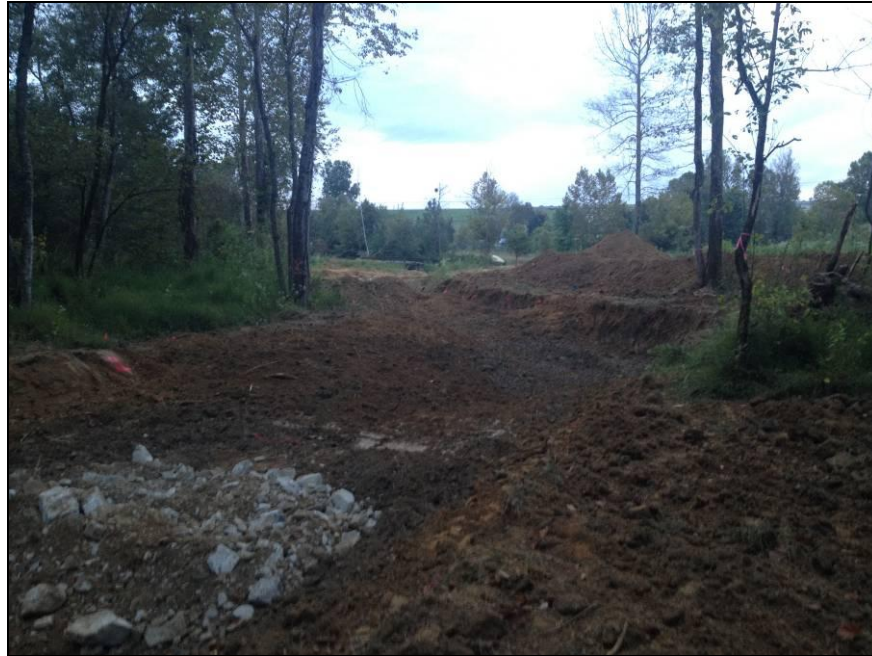
Reach downstream of migration barrier: Excavated channel in existing forest. Wolf Creek Dam can be seen in the background. (Picture taken looking upstream from ~ Sta. 109+50).

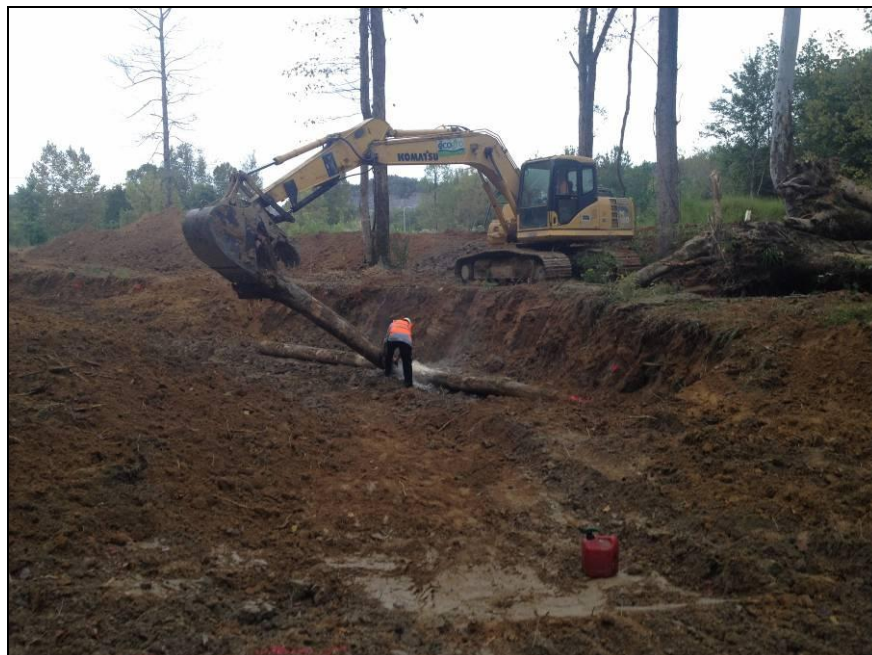
Installing rootwads as part of wood/rock toe bank structure. (Picture taken looking upstream from ~ Sta. 109+50).

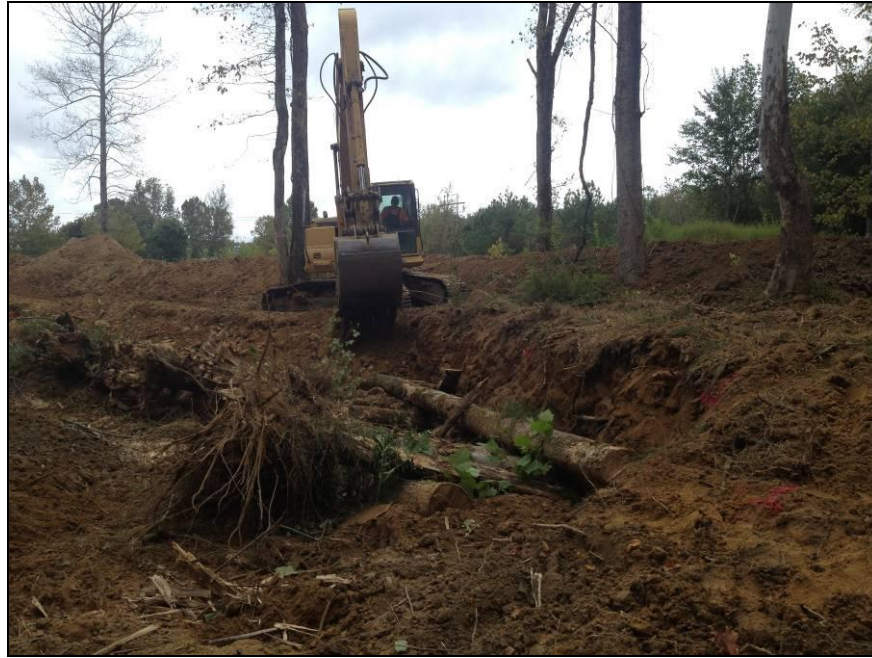
Installing rock on, and behind, rootwads as part of wood/rock toe bank structure. (Picture taken looking upstream from ~ Sta. 109+00).

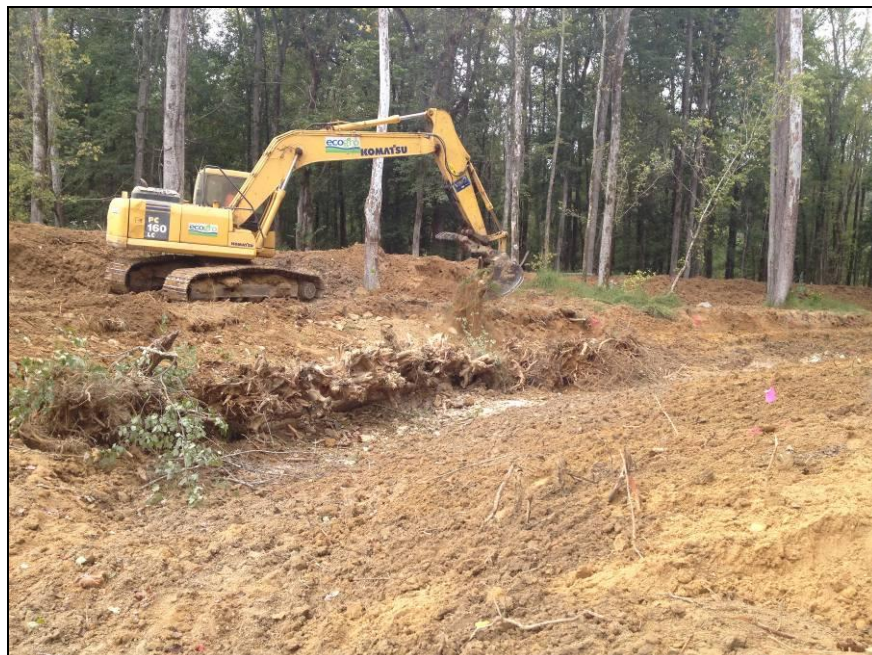
Another view of installing rock on, and behind, rootwads as part of wood/rock toe bank structure. (Picture taken looking downstream from ~ Sta. 108+20).

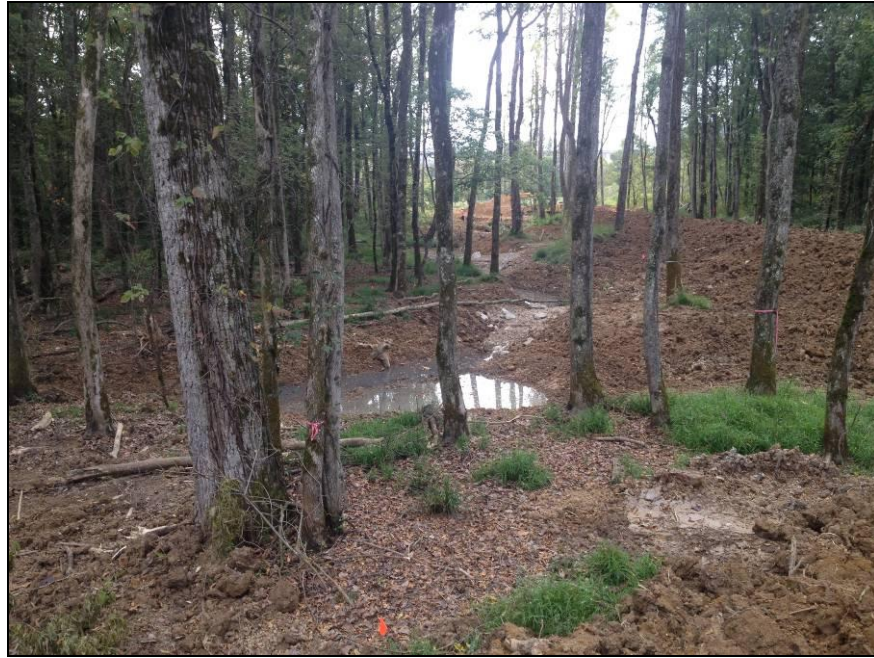
Left braid excavated and constructed in Wetlands Re-establishment Area 1. (Picture taken from top of floodplain berm looking upstream from ~ Sta. 112+00).

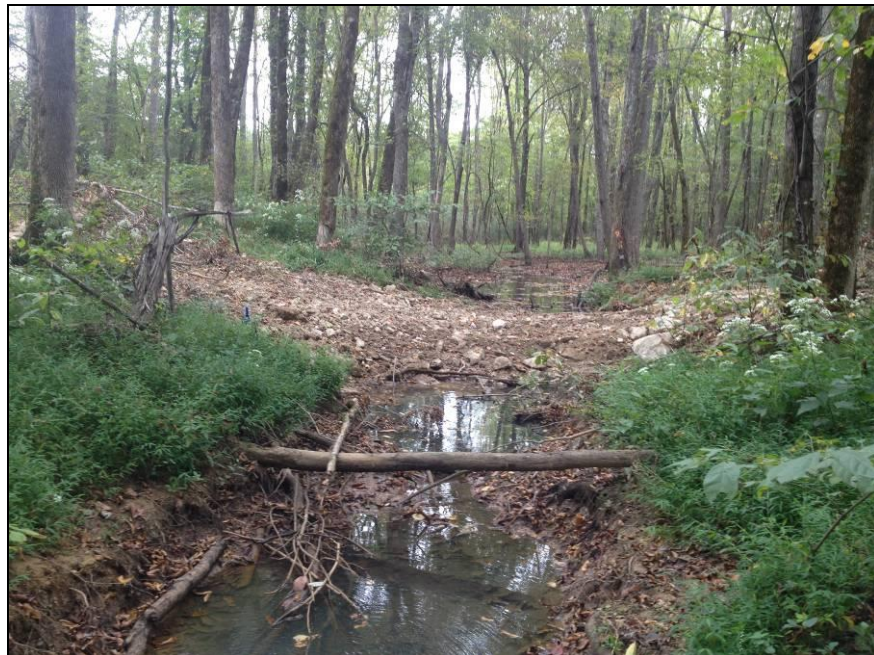
Constructed riffle at downstream end of Wetlands E to raise water table and enhance wetlands function.
